Guidelines for
**Preservation, Stewardship
& Development**

Guidelines for the
Preservation, Stewardship, and Development
of the
Dimock Community Health Center Campus
55 Dimock Street
Roxbury, Massachusetts

Prepared by August Associates, Architects
under contract with
Historic Boston Incorporated
with partial financial support through the
Boston Landmarks Commission
from the City of Boston
Neighborhood Development and Employment Agency
Community Development Block Grant funds.

November 1984

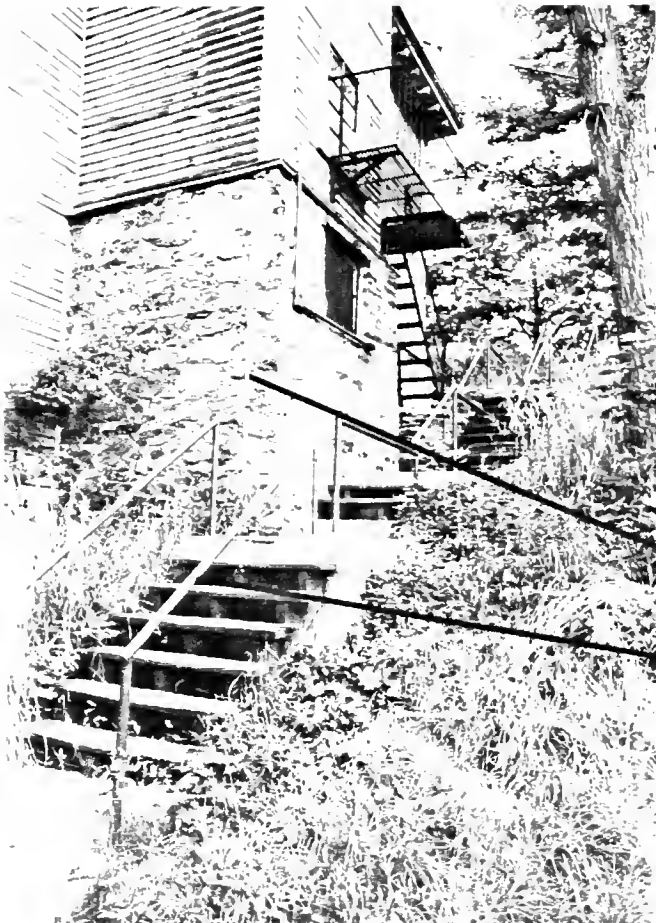
8

Puddingstone foundation wall

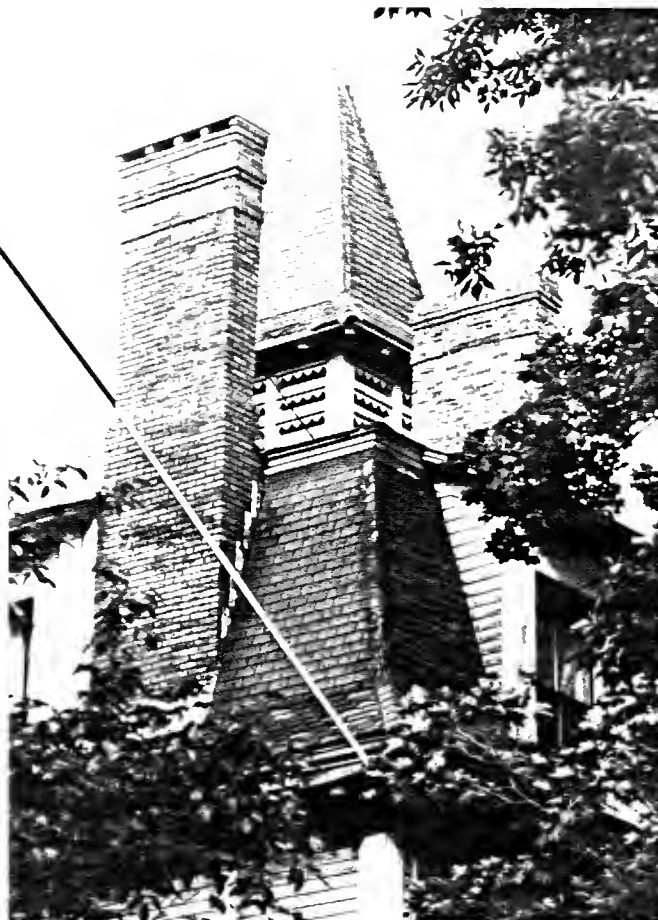
9

Damaged gutter and brackets

3. All exterior wood surfaces need to be repaired, scraped and sanded, restored, or replaced. (Photos # 1, 2, 3, 4, 5, 6, 7, 8, 9, 10)		Paint every 4-6 yrs

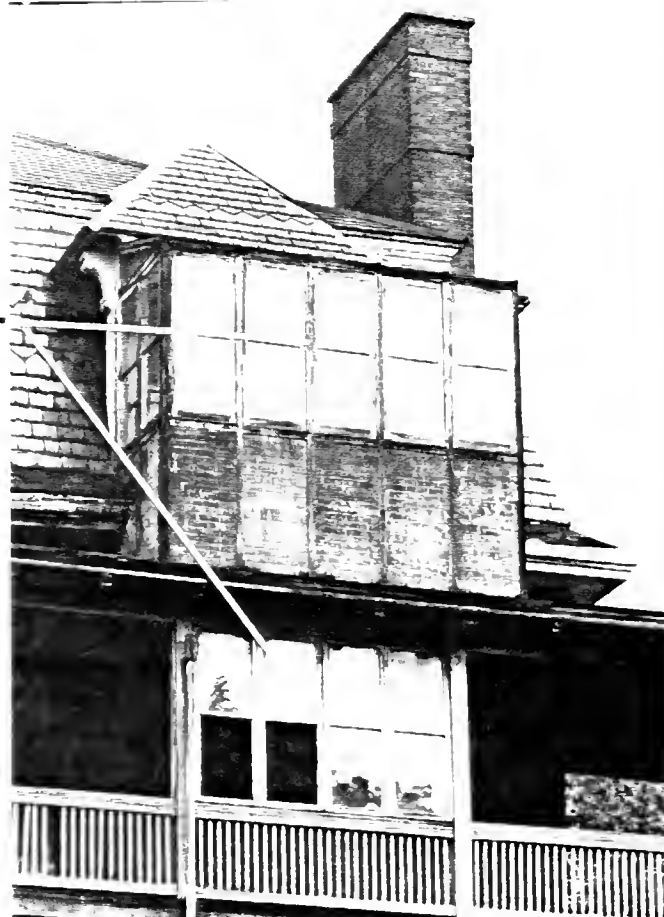
21

Added sun rooms, to be removed

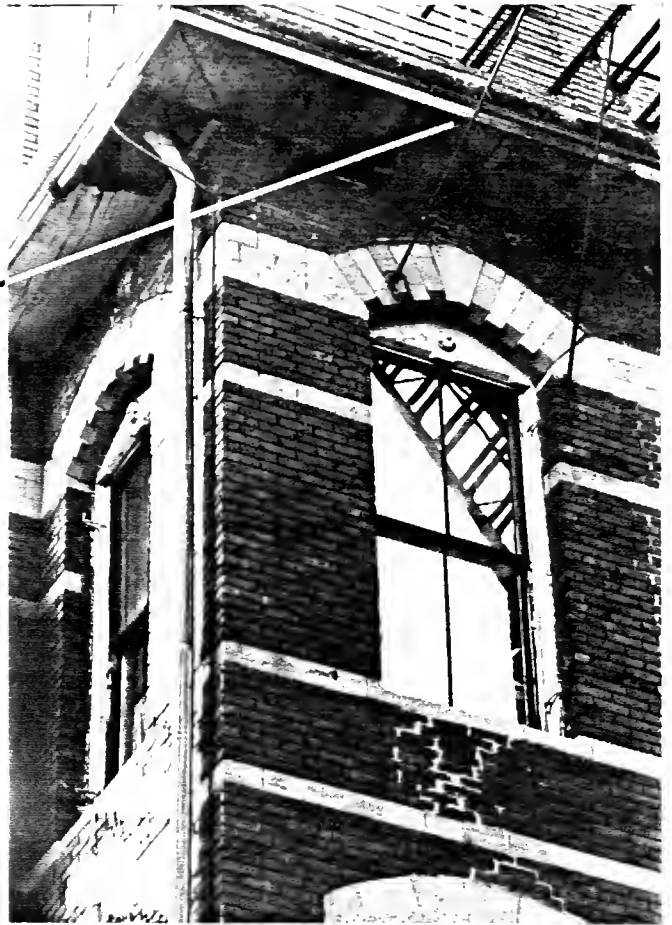
27

Wooden gutter and soffit area in need of repair

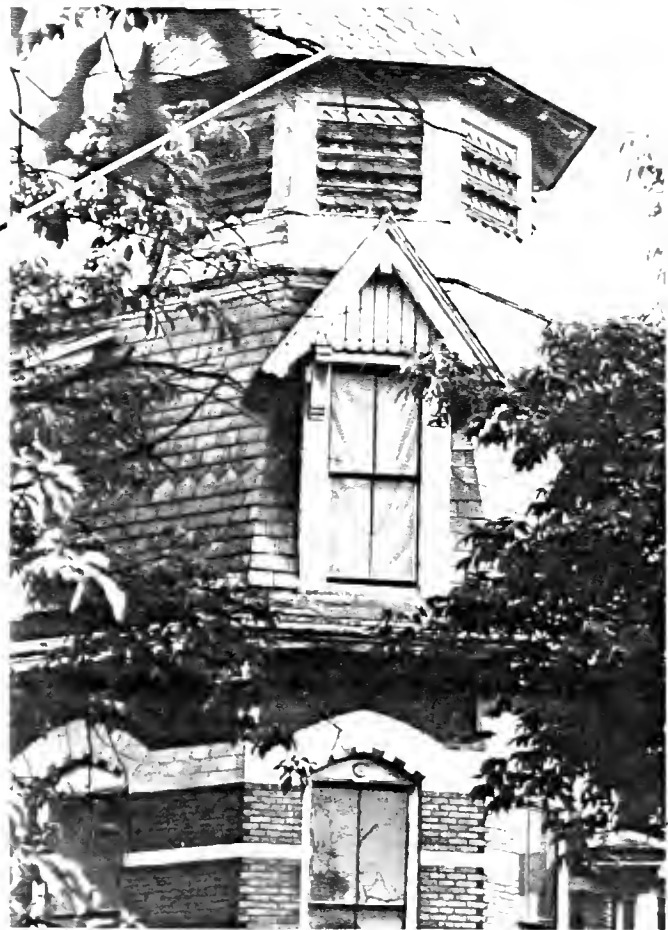
29

Wooden gutter and bracket in need of restoration

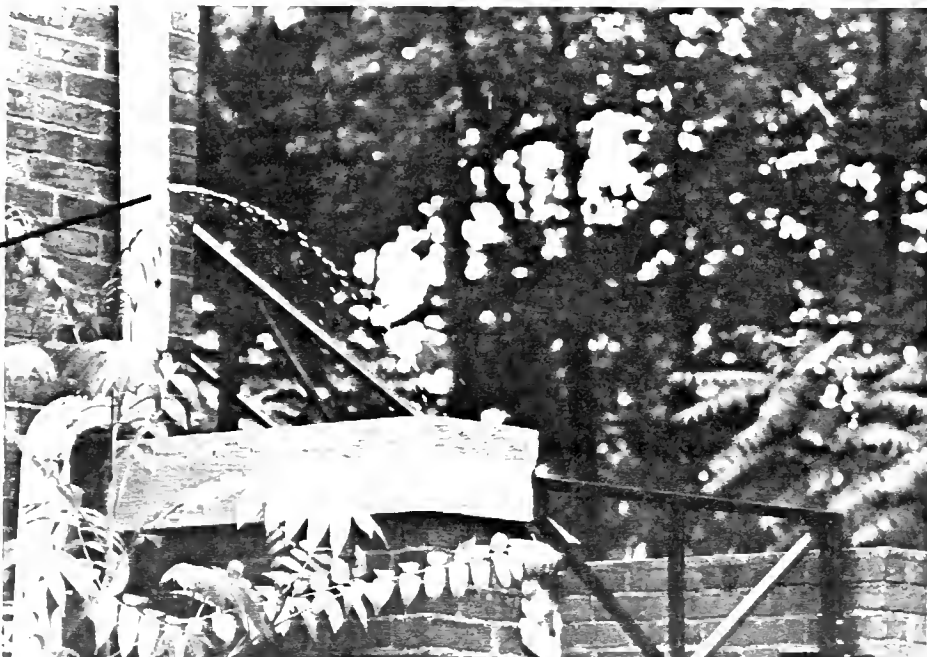
49

Downspout leak

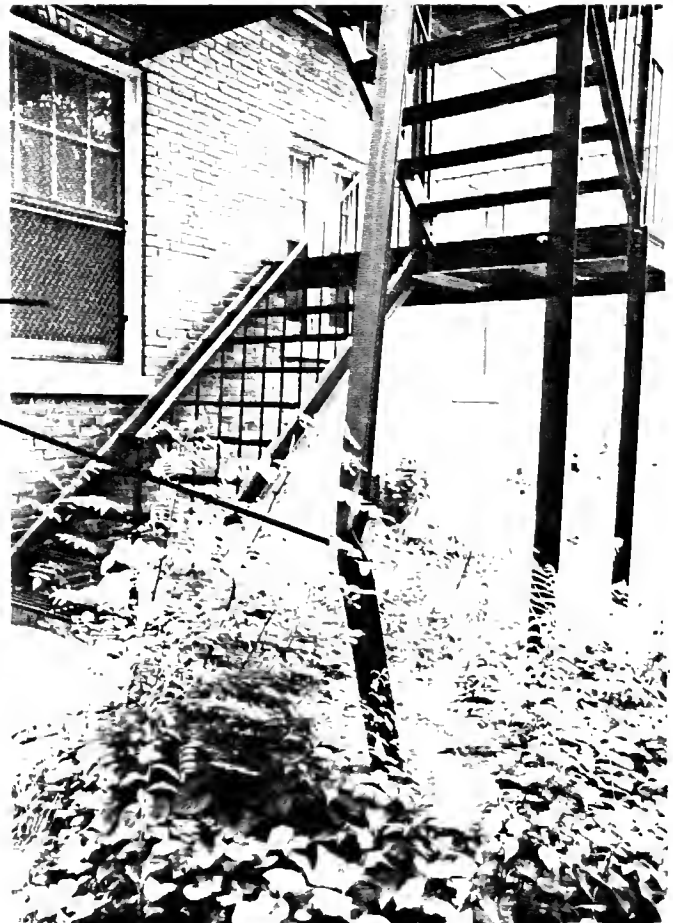
84

Damaged fire escape structural

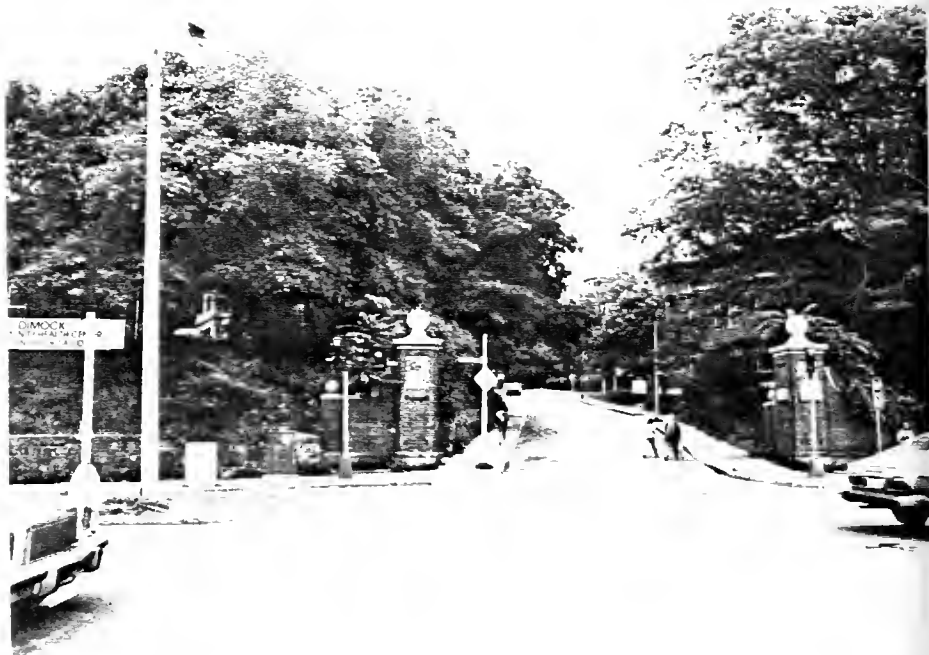
100

The Dimock Community Health Center sign should be on the brick entrance piers and not on the hill. The brick work and the stone wall need to be tuck-pointed.

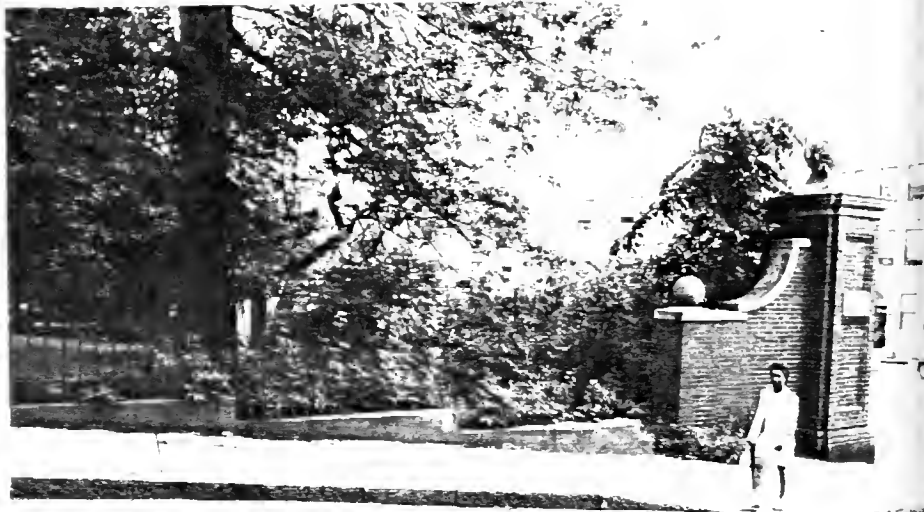
101

The iron fence needs to be repaired and/or replaced.

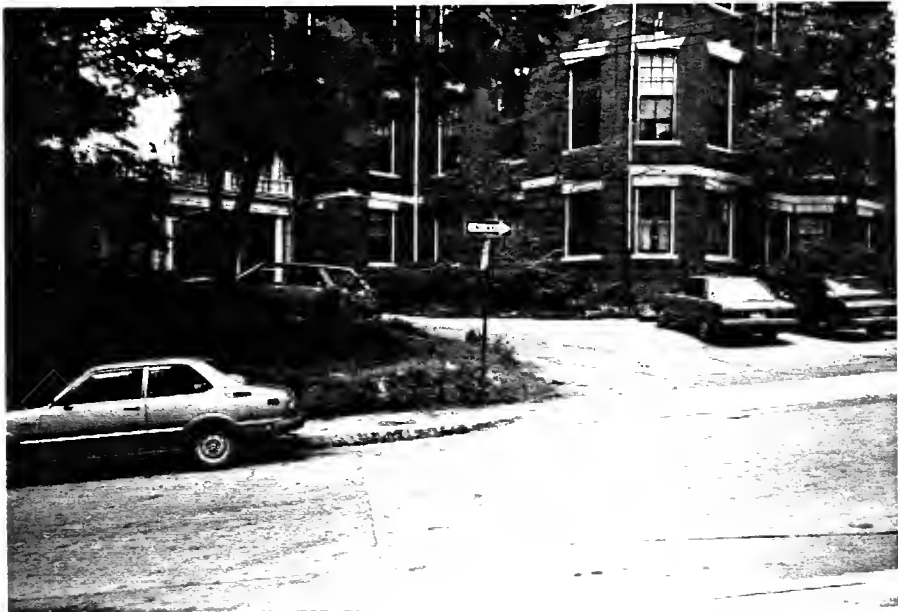
113

The Cheney entrance needs a better approach. This could be achieved by a narrower curb cut on Dimock Street.

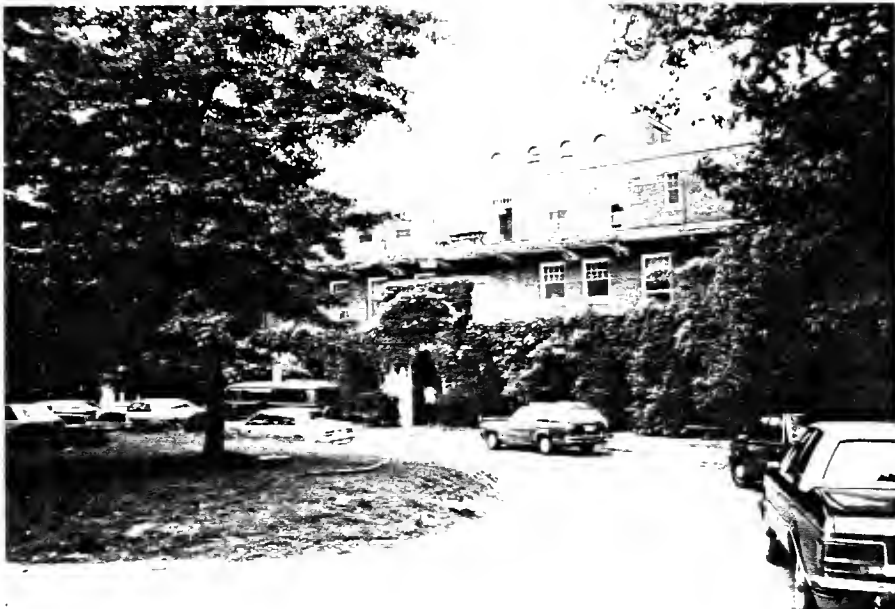
114

The vines obscuring the building lines should be removed. The road edge at the island need maintaining. A replacement tree (Pinoak) should be planted in the island.

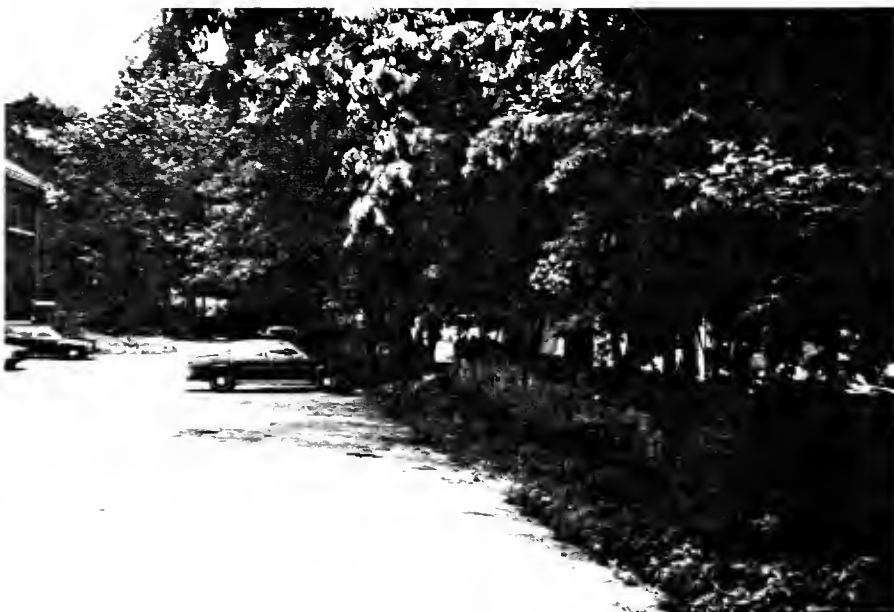
119

The east wall is nicely reinforced by deciduous trees. The wall needs to be tuck-pointed and the mowing strip maintained or replaced with groundcover.

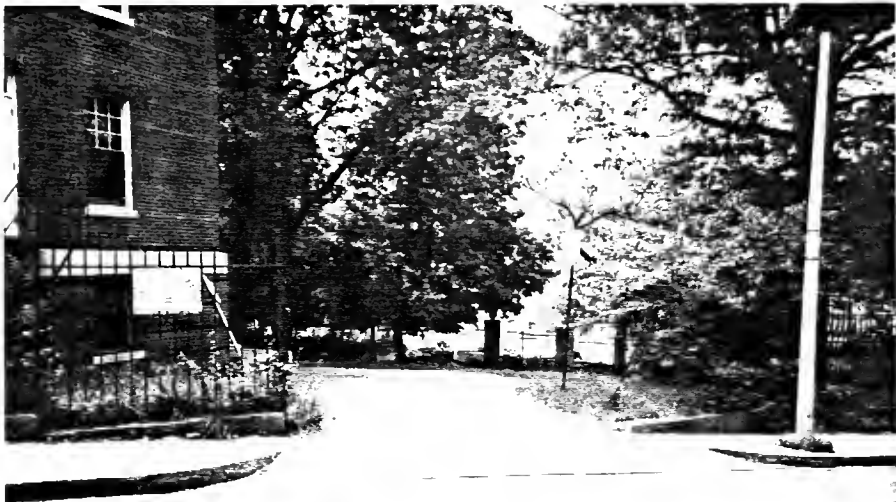
121

Iron fence should be continued to the drive.

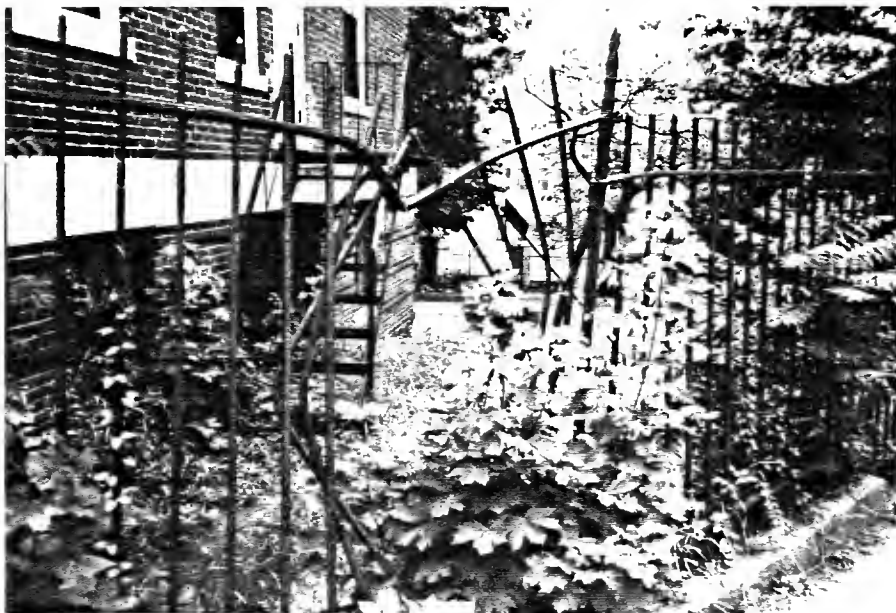
122

Fence repairs should be made and plants removed from the fence line.

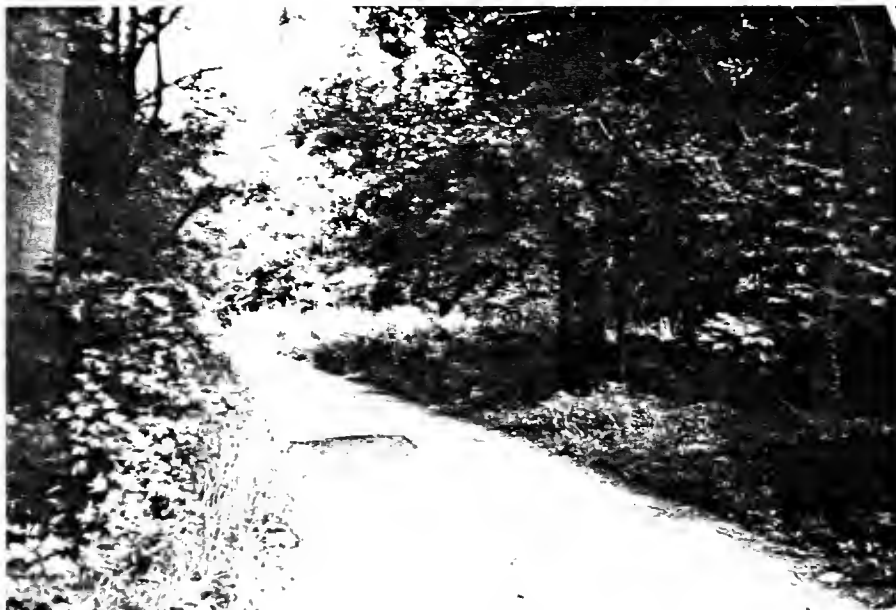
139

Trash from road edge to be removed, limbs pruned to give view across landscape, and road edge mowed.

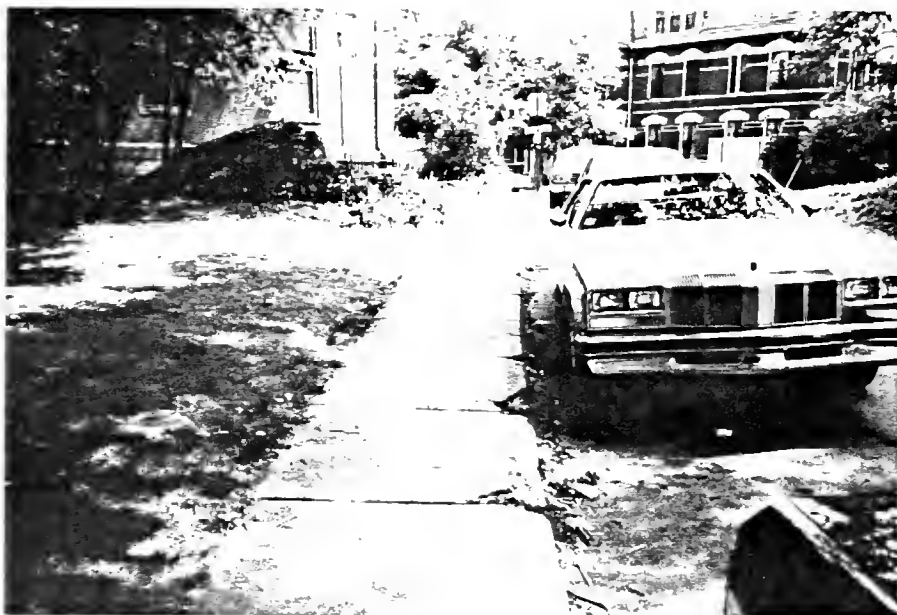
140

Sidewalk and curb needs to be repaired.
